# S2 Maintenance

Hub Not Shifting

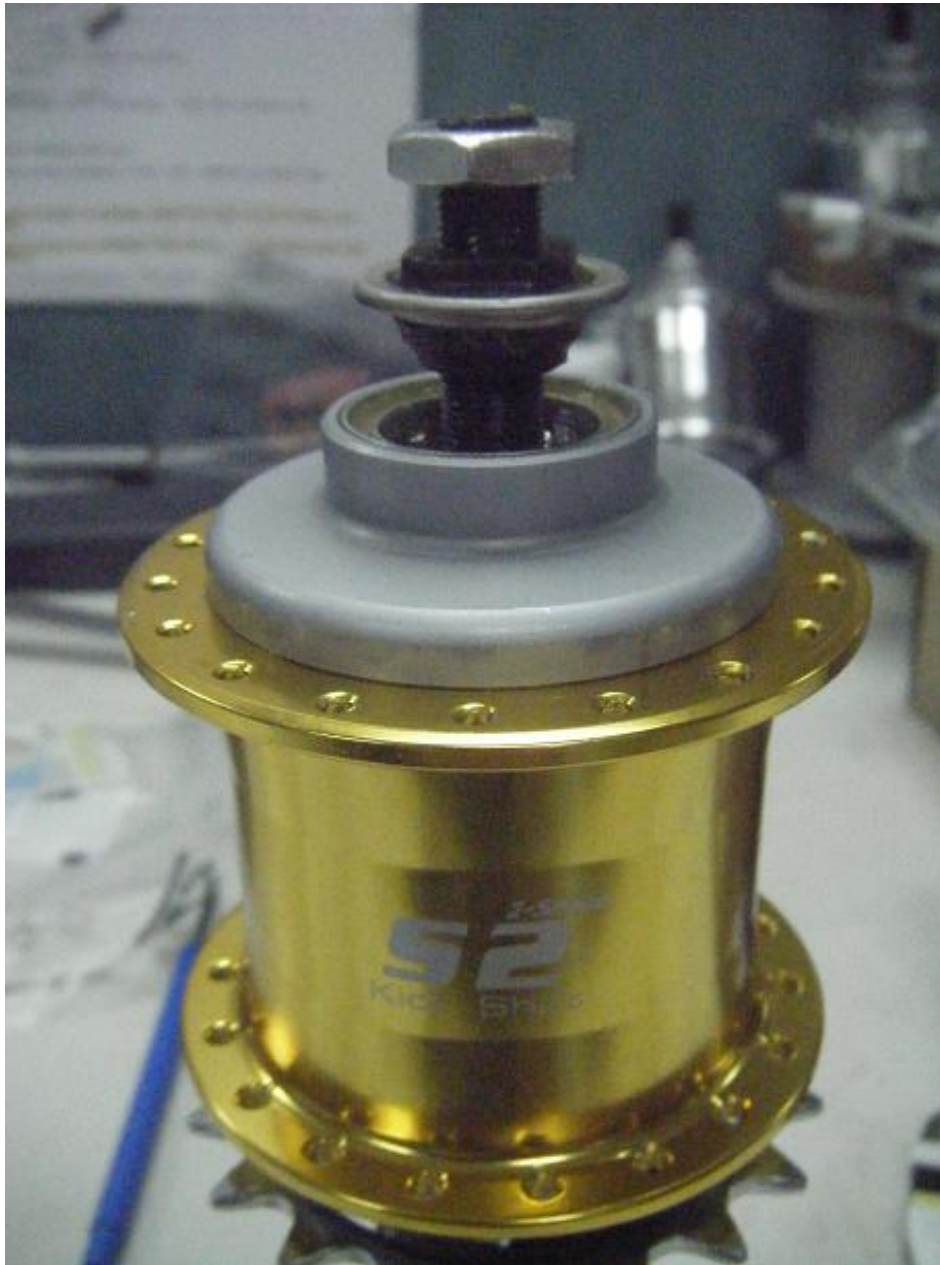
Step 1:  
Remove LH Nut  
And Cone

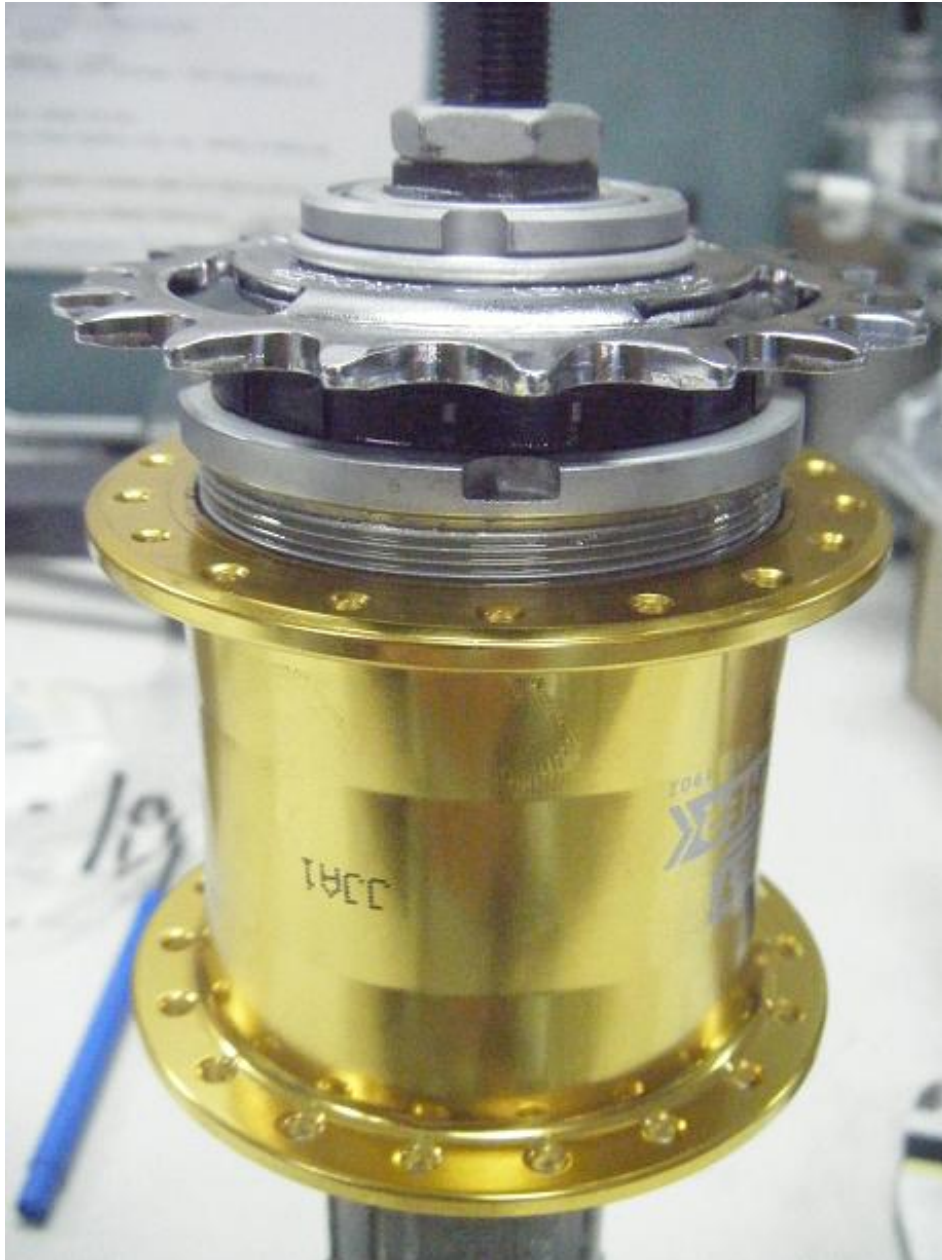
Step 2:  
Remove Internal. No  
proprietary tool is  
needed. Use a  
hammer and punch,  
hook spanner, or  
adjustable spanner to  
drift internal out. Left  
for loose.

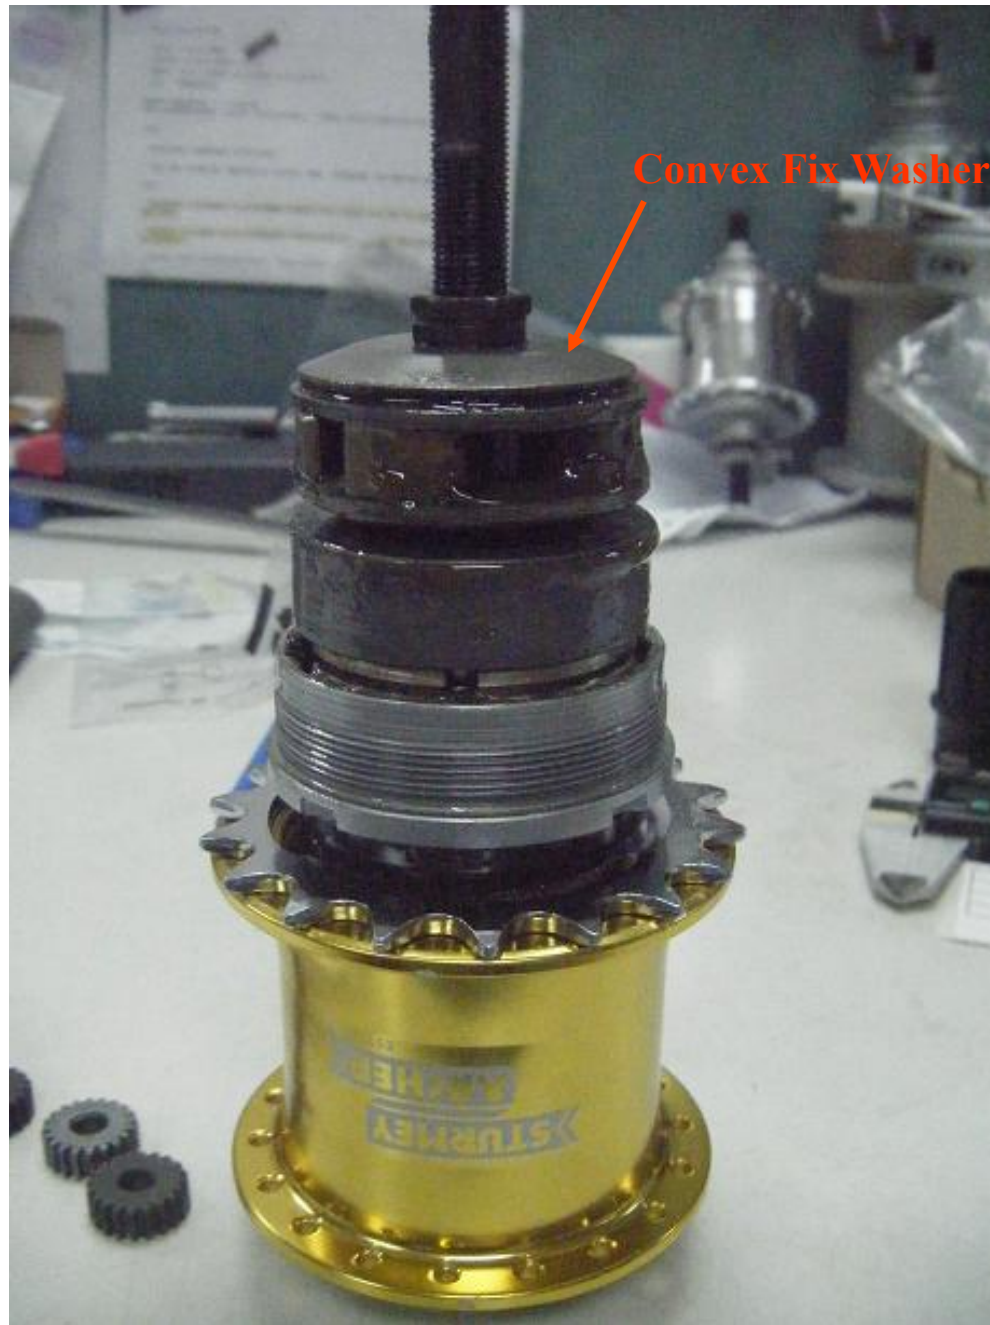
Step 3:  
Hold Axle  
securely, check if  
Convex Fix  
Washer is loose.

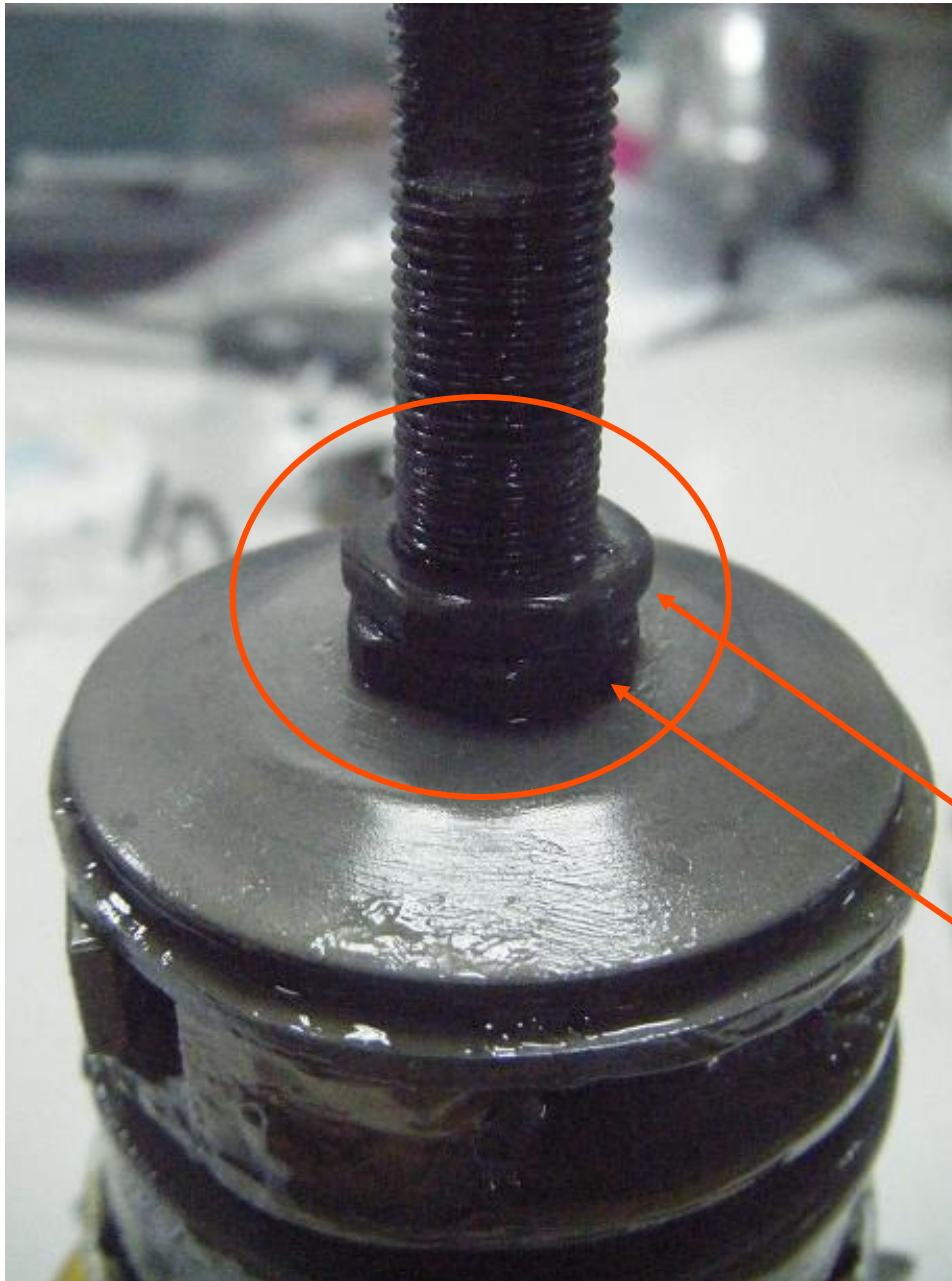
Step 4:  
Tighten Nut 1  
and Nut 2.

Nut 2

Nut 1

Replace internal  
and hub cones.  
Adjust hub cones.
